TS Type-B EN CINC

## Removing the Protective Material

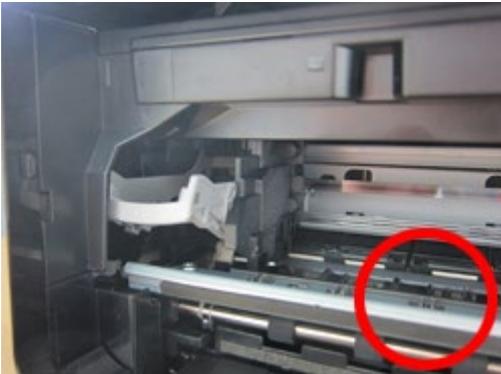
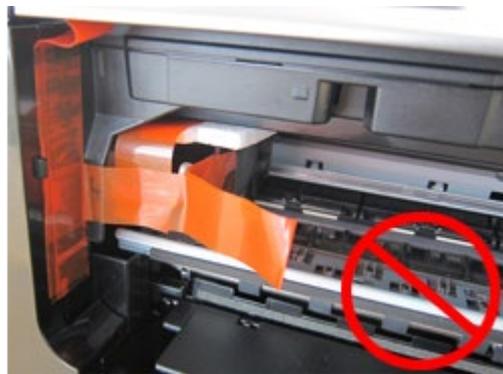
[ Protective tapes and white fixing material ]

When this error code is displayed at the initial setup, confirm that all the protective tapes and the white fixing material have been removed.

Cancel printing, turn off the machine. Then clear the jammed paper or protective material that is preventing the FINE Cartridge Holder from moving, and turn on the machine again.

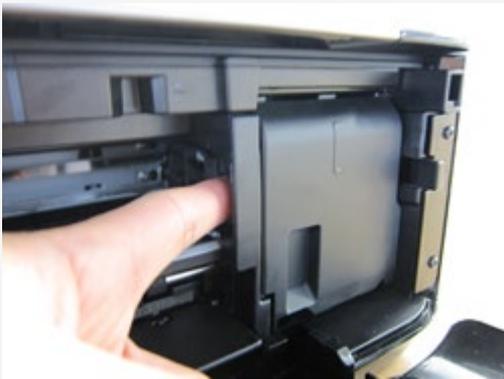
1. Turn OFF this product.
2. Push the left side of the FINE Cartridge Holder, then move it until it hits the right inner side of the printer.

On this occasion, do not touch the other parts.

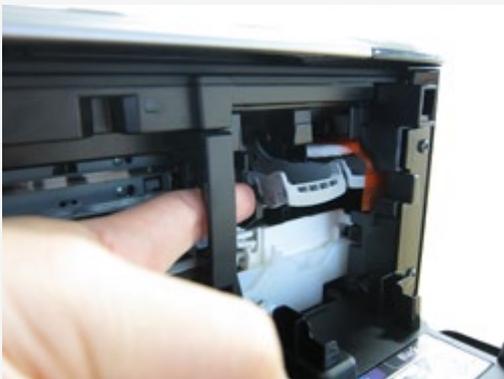
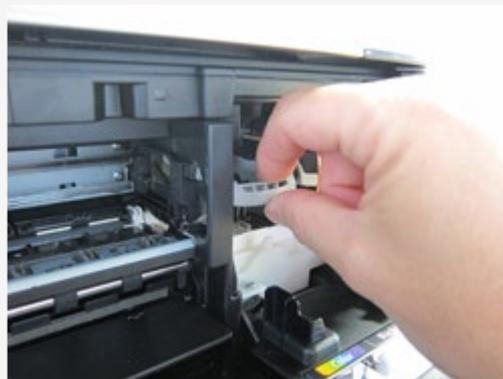
3. When the Head Cover opens, move the FINE Cartridge Holder to the position that the Ink Cartridge Lock Lever can be seen.

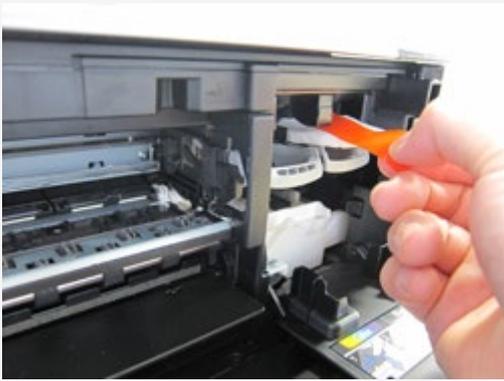
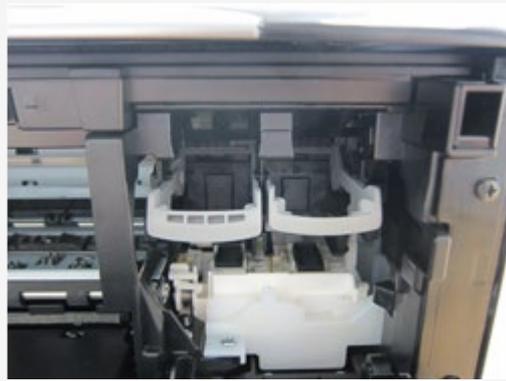
4. Remove the protective tape and the white fixing material attached to the FINE Cartridge Holder to confirm that the FINE Cartridge Holder is situated as shown below right.

5. Close the Head Cover and turn ON the printer, then confirm that the Head Cover opens automatically.
